REPORT ON THE
INSPECTION OF
NEW JERSEY STATE
HIGHWAY BRIDGES

REPORT ON THE INSPECTION OF NEW JERSEY

STATE HIGHWAY BRIDGES

Inspection was made during the winter of 1958-59 of 44 bridges geographically situated in all sections of the state.

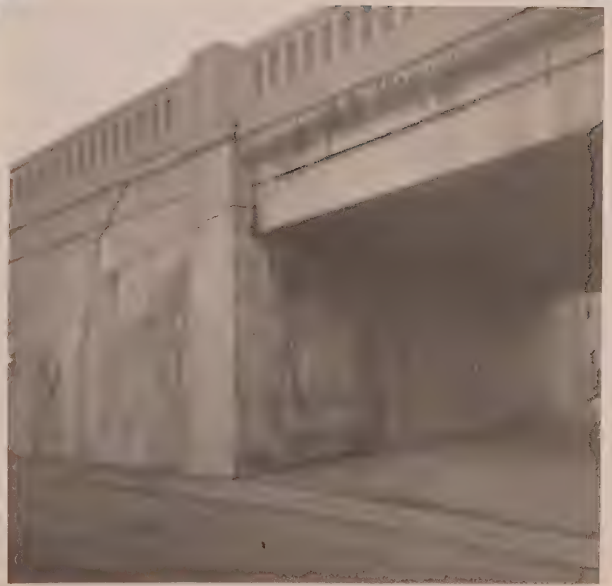
BRIDGE NO. 1

Condition - West abutment has settled causing horizontal cracks. Abutments and approach retaining walls cracked. Poor drainage. Considerable crystalline deposits on concrete faces. See photos.

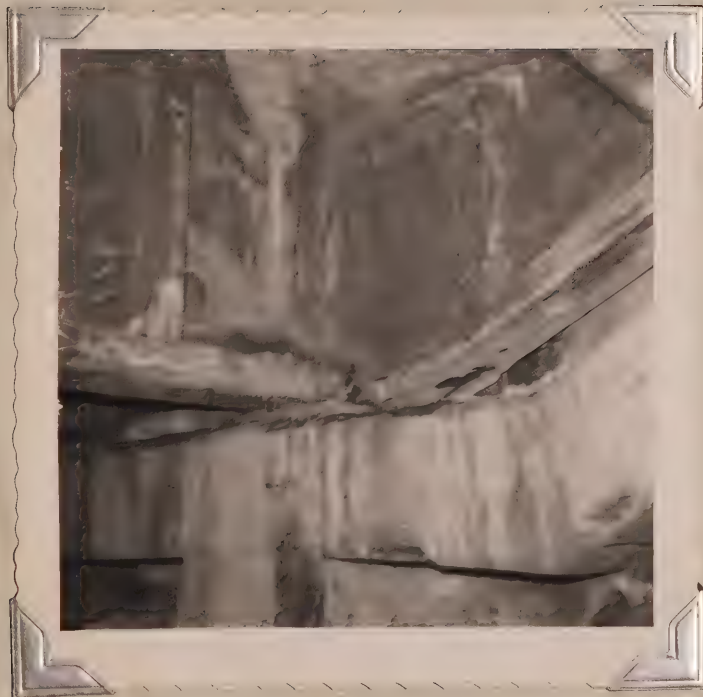
Condition - Same disintegration of the concrete cover over the structural steel. Crystalline deposits on the concrete cover. Photo shows leeching and disintegration at east abutment. Piers in good condition. Repairs have been made on balustrade and at the water table at the base of balustrade.

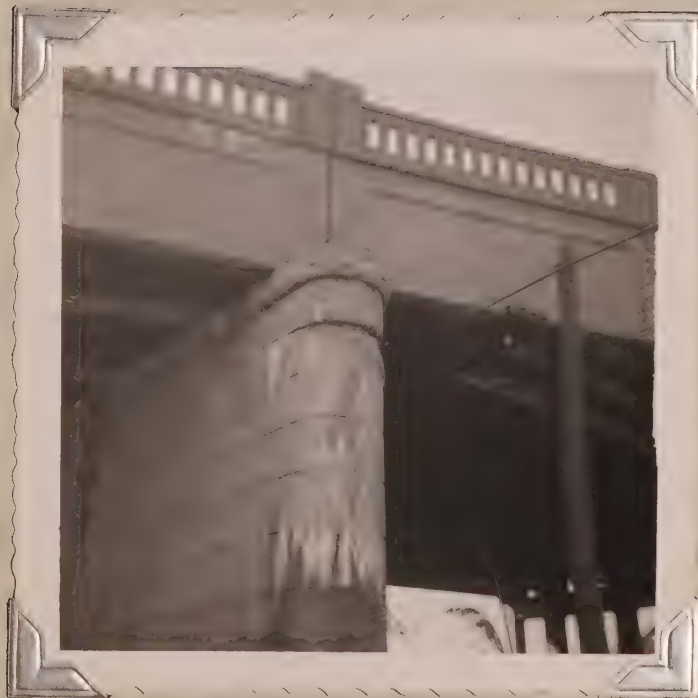
BRIDGE NO. 3

Condition - Abutments in good condition. Considerable crystalline deposits on underside of bridge beams. Piers are cracked, concrete has spalled and is disintegrating. Some leeching at the top of the exterior beams. South face of center pier has been repaired. Horizontal crack occurs at coping of southwestern wing wall. Photos show piers and girder encasement near the support.

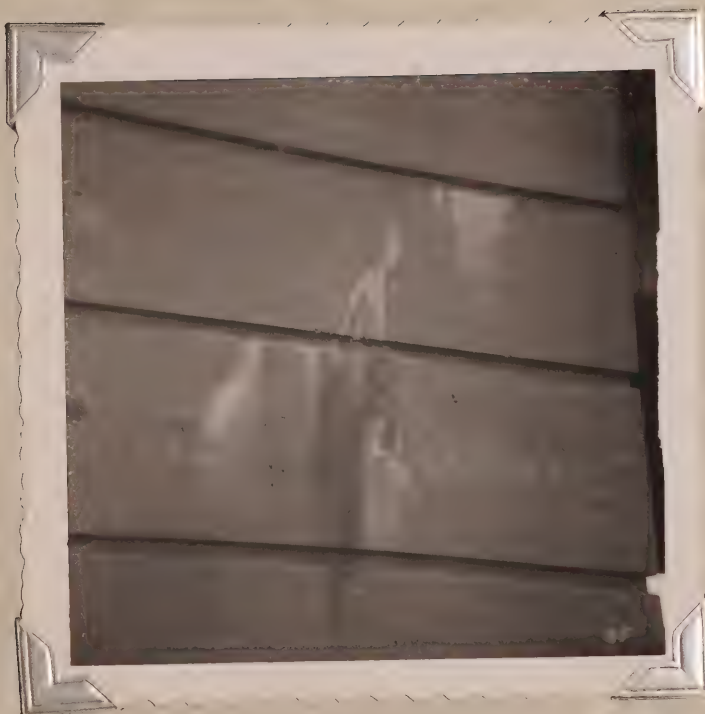
Condition - Some vertical cracking in abutment walls.
No disintegration of concrete anywhere.
Some vertical cracks in abutments. Photo
shows crystalline deposits at vertical
crack at rustications east bound side.

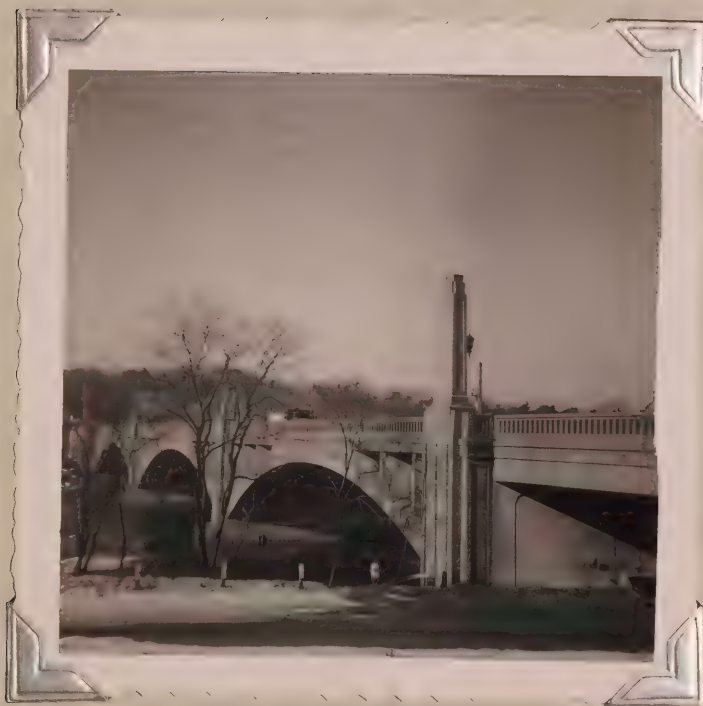
BRIDGE NO. 8

Condition - At the top of the abutments on the west end, vertical cracks appear at the bearings and in some areas the concrete has sloughed off at these locations. Considerable crystalline deposits under the approach spans. Vertical crack appears on west end abutment (see photo). Arches in sound condition. East end approach not as bad as west end. Some disintegration of concrete at the bearings on the east abutment.

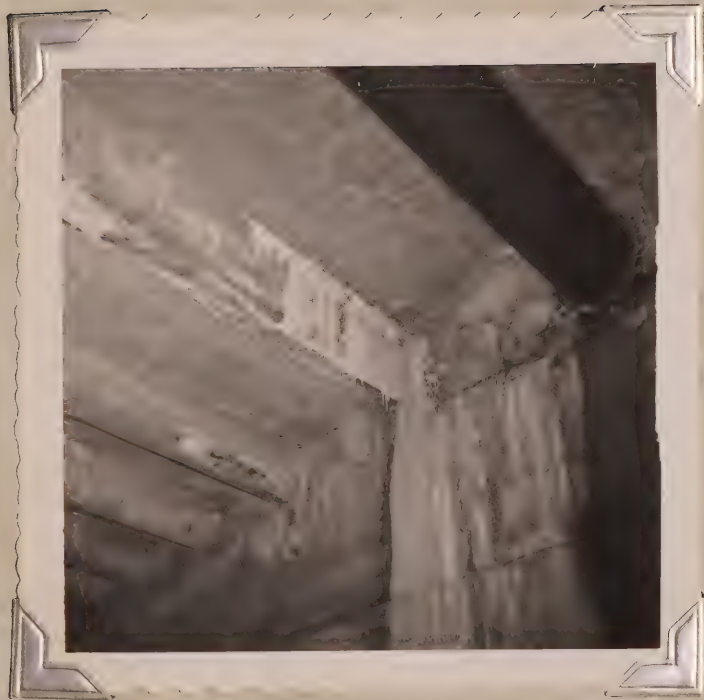
Condition - Abutments in sound condition. Considerable crystalline deposits on soffit sides of beams and junction of slab with the concrete cover (see photo). Where concrete is exposed to weather, aggregate is exposed in some areas. Piers in good condition.

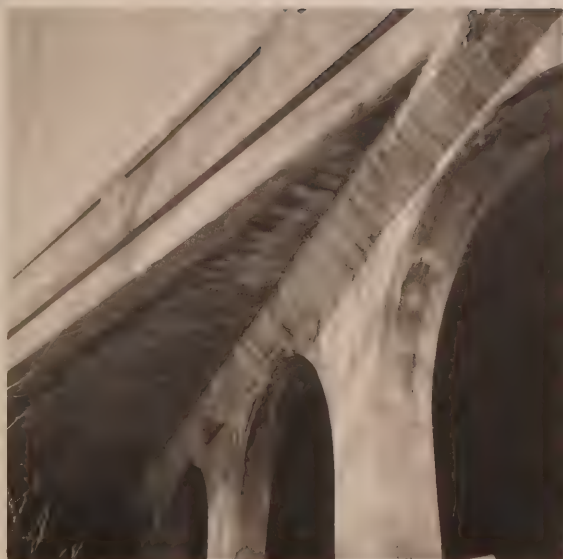
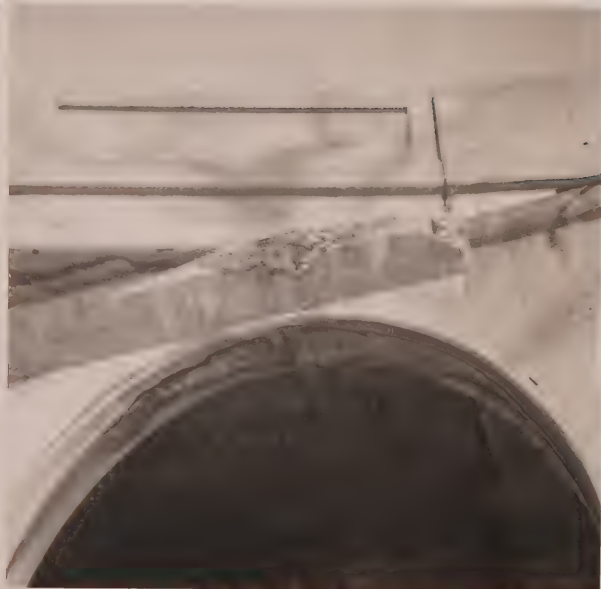
Condition - Wing walls and retaining walls in sound condition. A few rock pockets in piers. Some broken concrete at top of one pier at one location (see photo). Crystalline deposits on some areas at the junction of the slabs with piers (see photos).

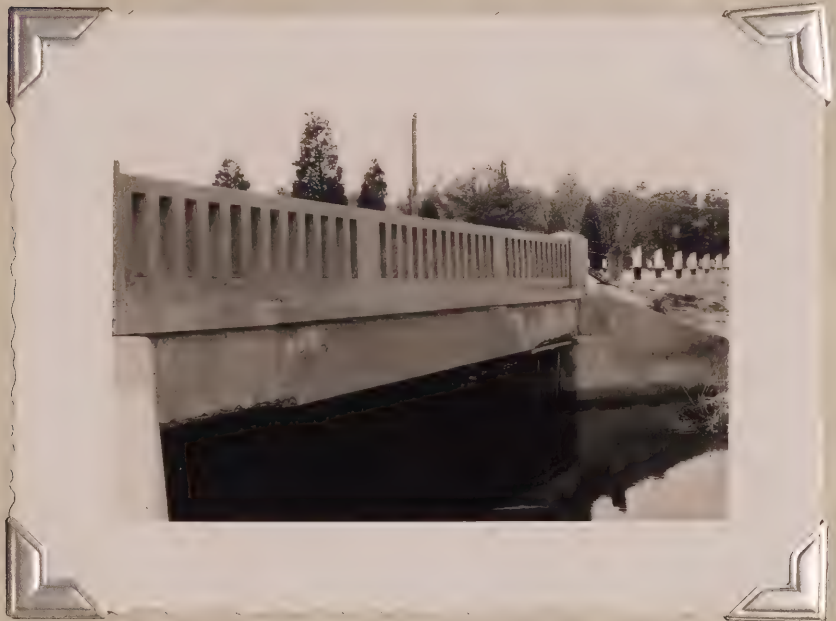
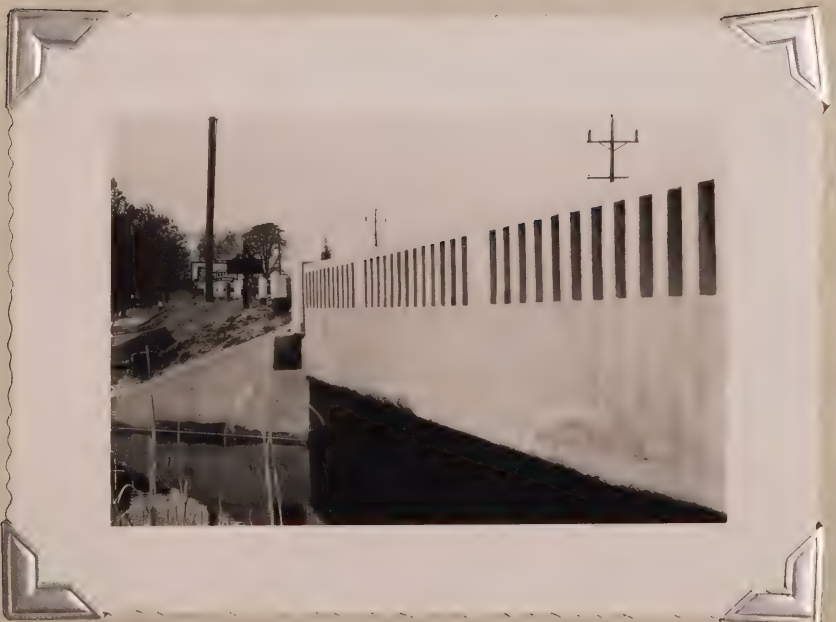
Condition - Repairs have been made on faces of exterior beams. On upstream side, the concrete cover has come off the bottom longitudinal steel on the exterior girder at both ends. Timber supports are under the girder at one end. See photos.

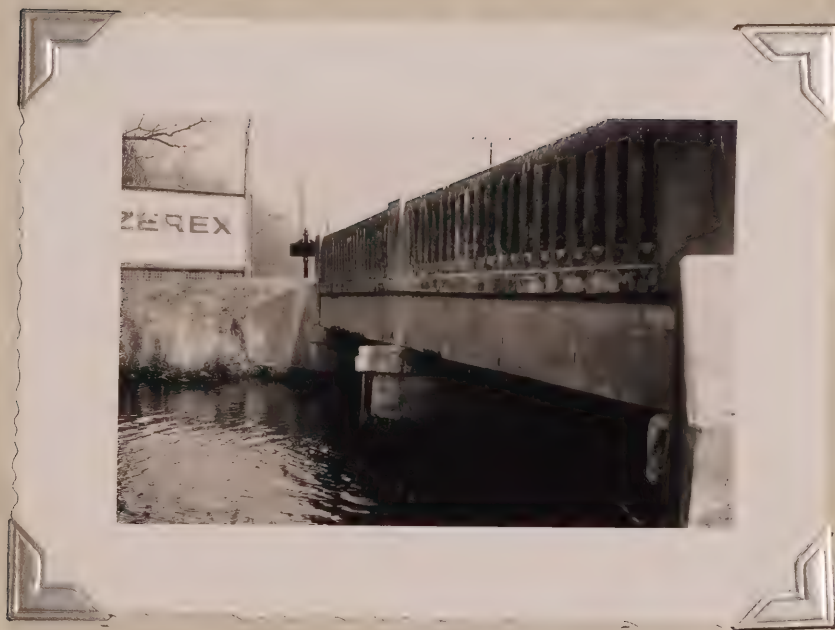
BRIDGE NO. 12

Condition - Concrete cover has come off the bottom reinforcing steel on one exterior girder. Disintegration of concrete on top of balustrade post. Crystalline deposits on face of exterior beams. See photos.

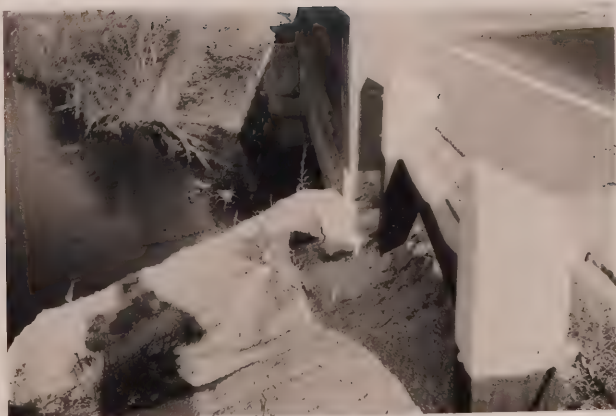
BRIDGE NO. 13

Condition - North wing walls in sound condition. Coping on south end wing walls badly disintegrated. Balustrades in good condition. Curb on upstream face disintegrated on south end. Upstream exterior girder shows some vertical cracking. abutments in sound condition. See photos.

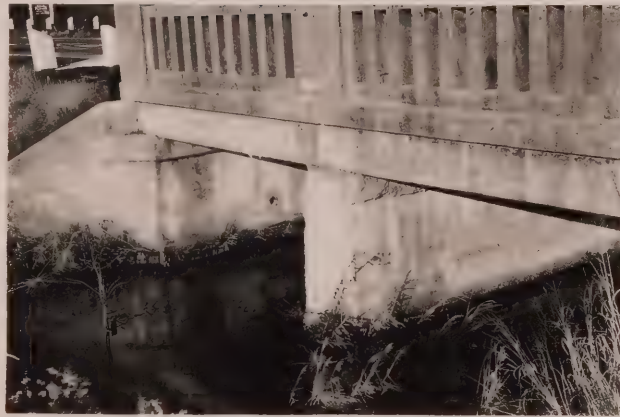
Condition - On pier on west side the coping and vertical edge the concrete has disintegrated. On pier on upstream side the concrete has disintegrated at the top surface. Some surface cracking on the southeast wing wall. One vertical crack is seen on northeast wing wall. Wing walls on west side are in good condition. Cracking accompanied by crystalline deposits are seen in the vertical exposed sides of the slab. See photos.

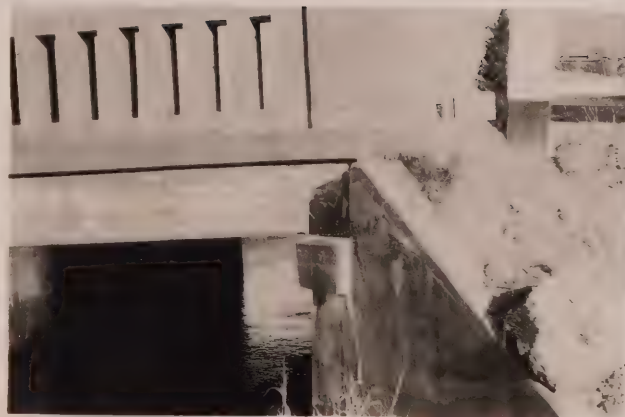
BRIDGE NO. 15

Condition - Concrete on pier on upstream face disintegrated. Coping on the abutment and coping on wing wall both at northwest corner have disintegrated. Cracking accompanied by crystalline deposits are prevalent throughout. On the balustrades reinforcing bars are exposed. Concrete is etched at the water level. See photos.

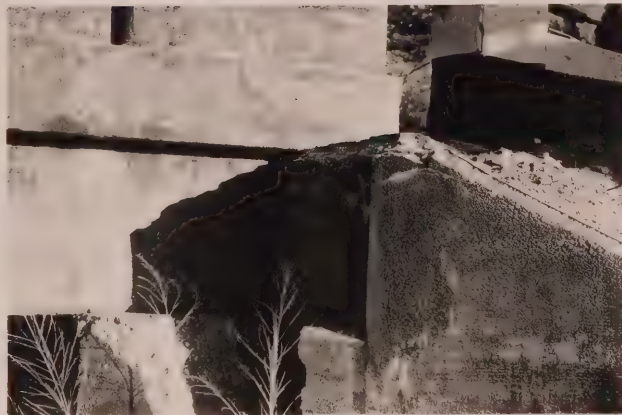
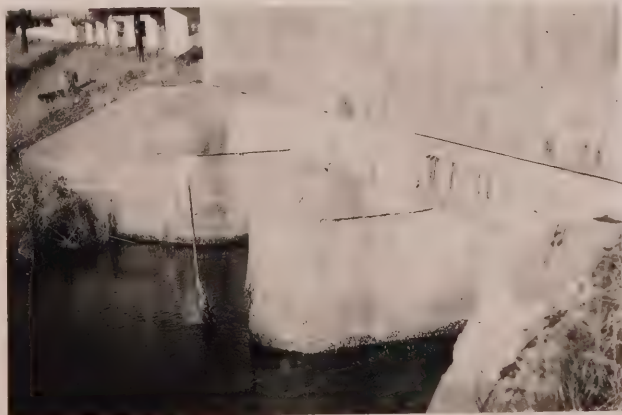
Condition - Pier tops on both sides of the bridge disintegrated coping on wing wall on southeast corner disintegrated. Large horizontal and vertical cracking on northeast wing wall. All vertical surface badly cracked accompanied by crystalline deposits. Concrete is etched at the water level. See photos.

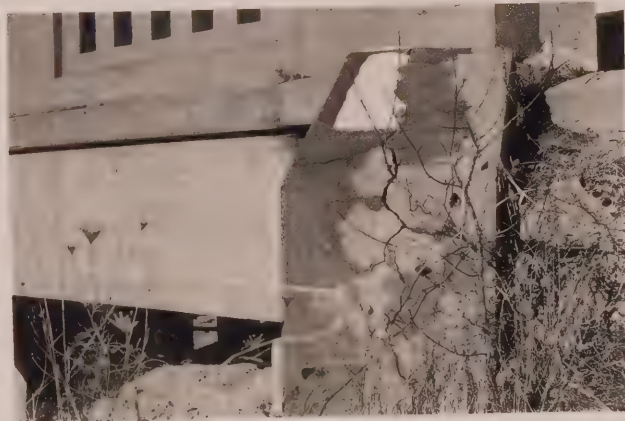
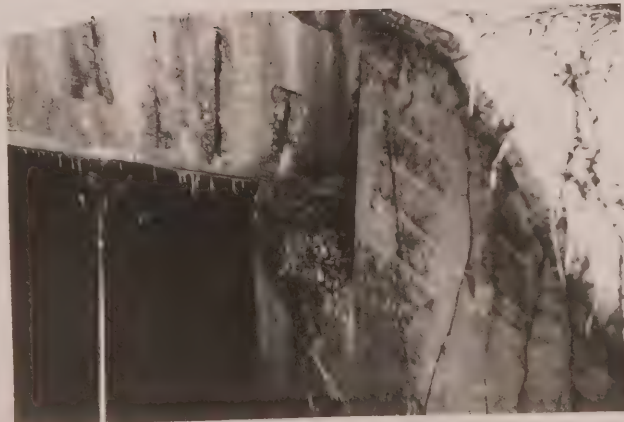
Bridge No. 17 is an example of concrete deterioration caused by a pipe line at the water table.

Condition - Water table under the pipe line on the upstream face disintegrated. Reinforcing steel seen exposed on vertical side of exterior beams. Vertical cracking on wing wall at southwest corner and at this location the horizontal surface of the wing wall adjacent to the bridge is disintegrated. Considerable crystalline deposits on sides of exterior beams. Concrete is etched at water's edge.

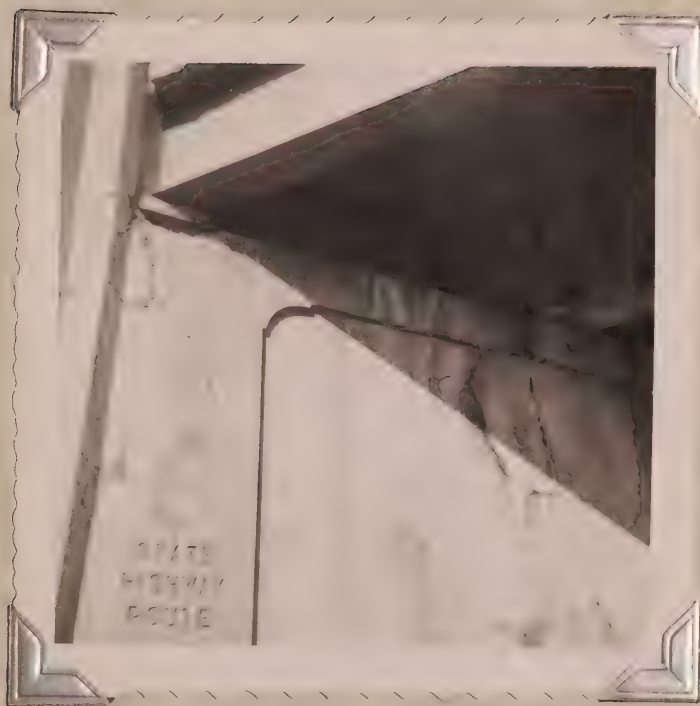
BRIDGE NO. 18

Condition - Concrete chipped away at bearings. Many cracks in face of north abutment accompanied by crystalline deposits. Poor drainage. See photo. Center pier and south abutment in sound condition.

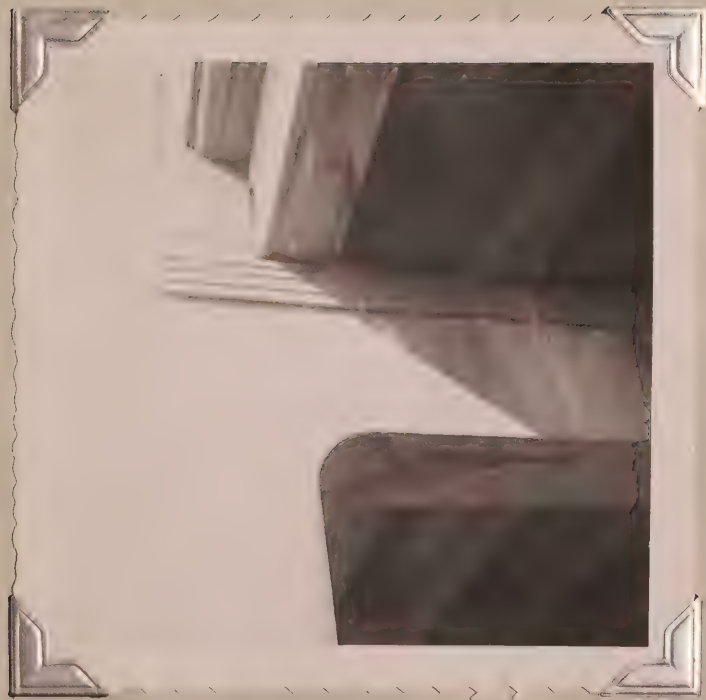
Condition - On south abutment the concrete was chipped
away at the bearings. Crystalline deposits
seen on vertical faces of piers. See photo.
Structure is in good condition.

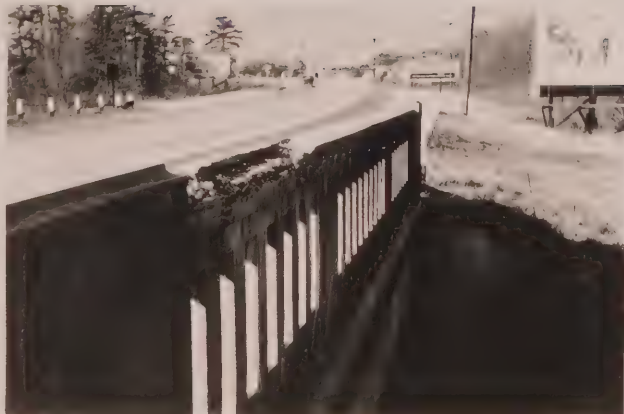
Condition - Upstream and downstream faces in good condition. Parts of the top of balustrade on both sides disintegrated. See photo.

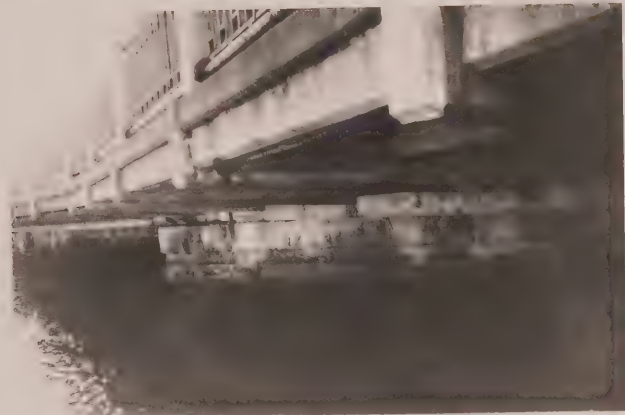
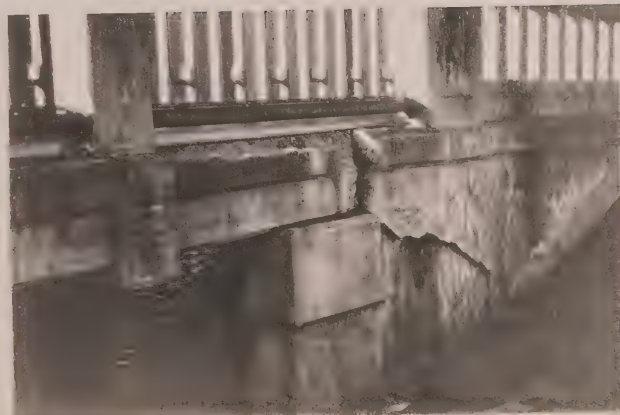
Condition - At the northwest corner at the abutment there is seen evidence of a movement (see photo). Except for some minor disintegration at the base of the balustrade posts and some water leakage at the abutments underneath the bridge is in good condition. Crystalline deposits are seen on the piers and deck.

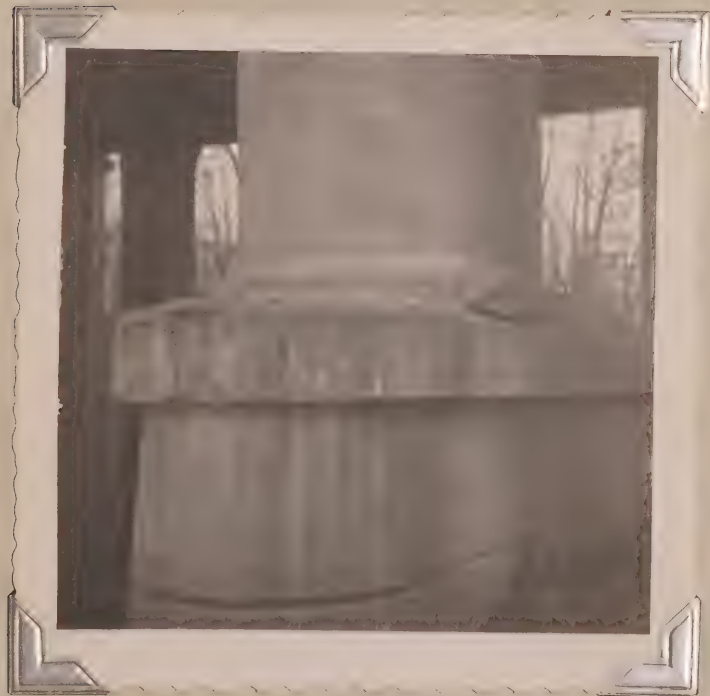
BRIDGE NO. 22

Condition - Copings at top of piers disintegrated. In some locations the concrete at base of columns has disintegrated. Coping on one wing wall completely disintegrated. Side walk, used to store cinders and calcium chloride, completely disintegrated. Exposed reinforcing steel on underside of slab and in a few beams. Extensive repairs have been made on bottom of deck. Vertical faces of piers at river, both upstream and downstream, show signs of disintegration. Large areas of vertical surfaces covered with crystalline deposits. See photos.

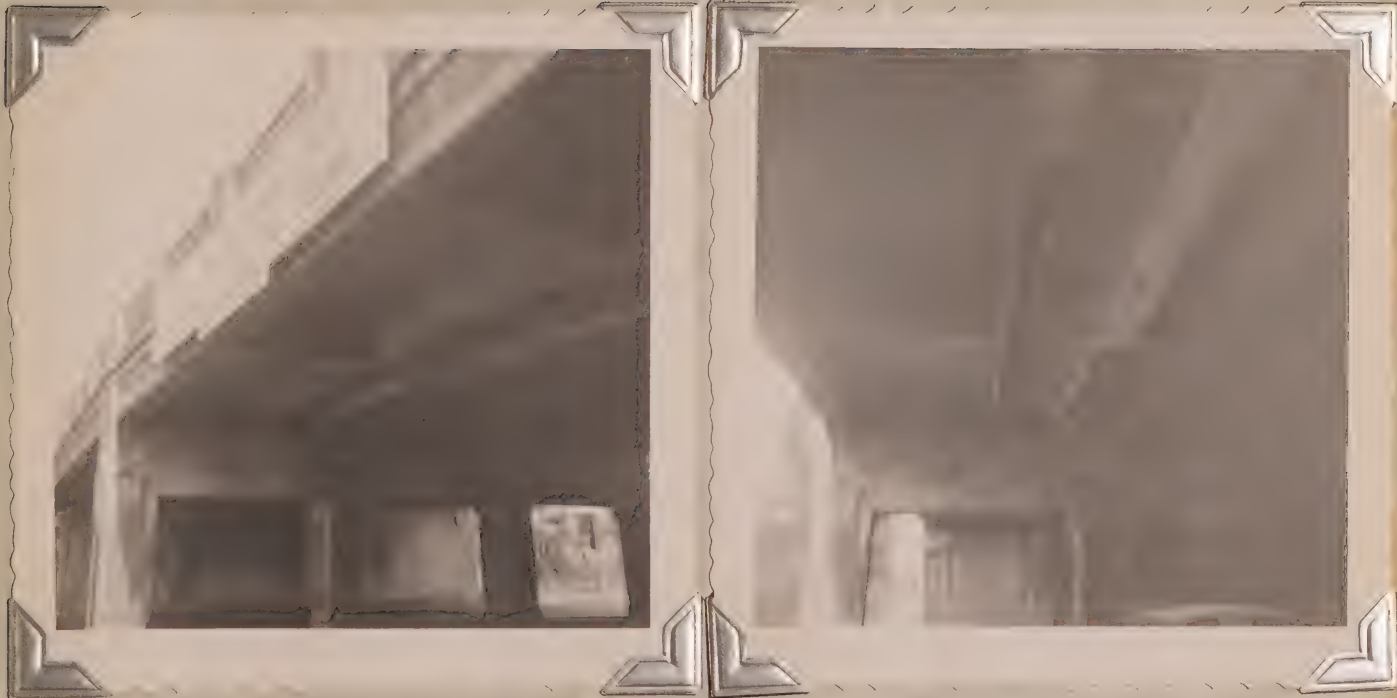
Condition - Concrete cover removed from the soffit of steel beams in some areas. Concrete at top of abutments disintegrated at the ends of the pier. There is disintegration at coping level. Photos show pier and west side.

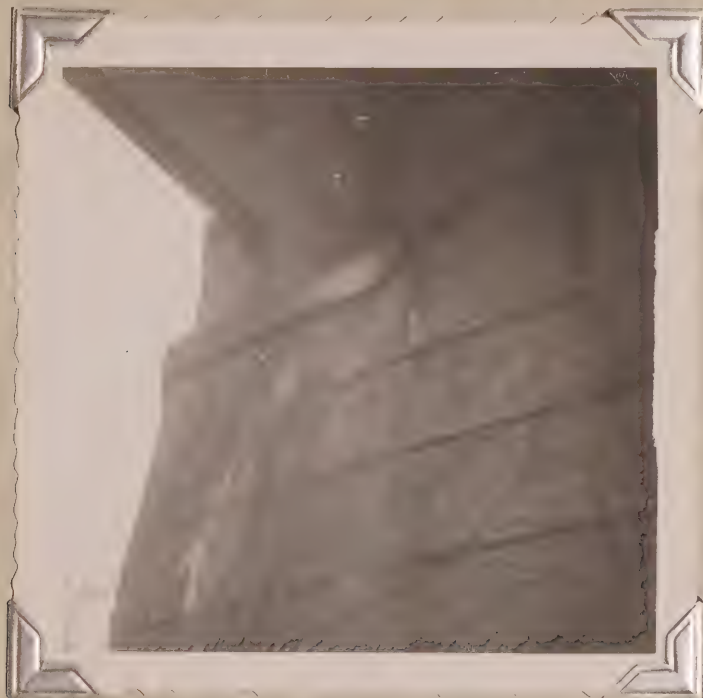
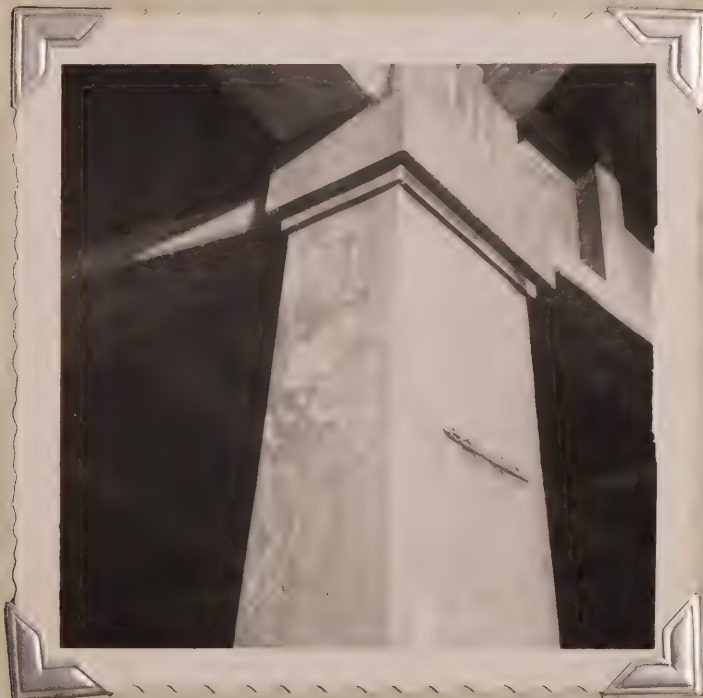
Condition - The underside of deck covered with crystalline deposits. Some vertical cracking at abutments. Steel exposed in one of the columns. See photos.

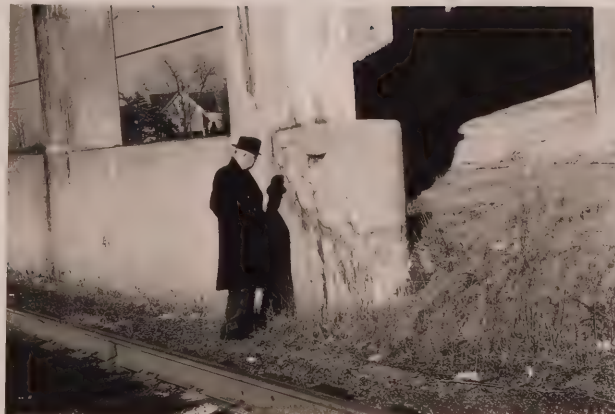
BRIDGE NO. 26

Condition - Piers cracked. Crystalline deposits
through cracks and on underside of deck.
See photos.

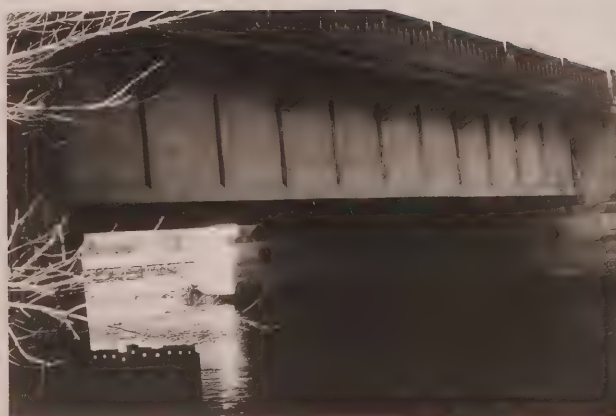
Condition - Large vertical crack in center of west
abutment. Some slight cracking on sur-
face. Concrete is etched at water's
edge. Bridge in good condition. See
photo.

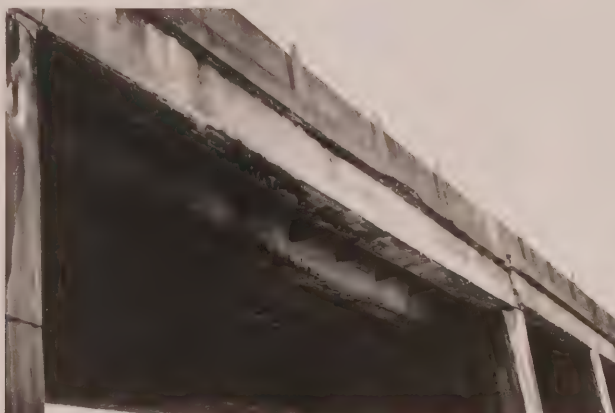
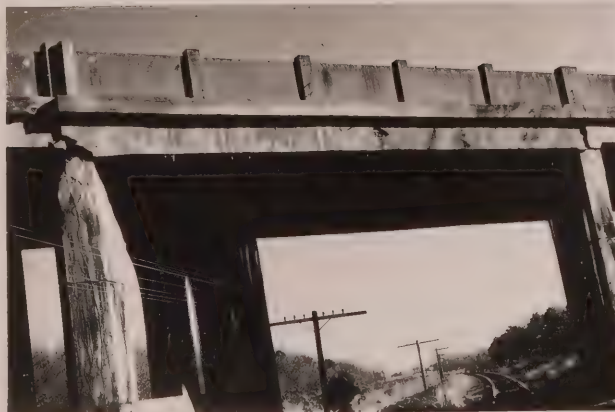
Condition - Lateral movement of the span over the tracks on the north side. Balustrade apparently not the original. Cracking of concrete surface of piers and concrete cover accompanied by considerable crystalline deposits. Signs of water seepage from deck to piers and abutments. See photos.

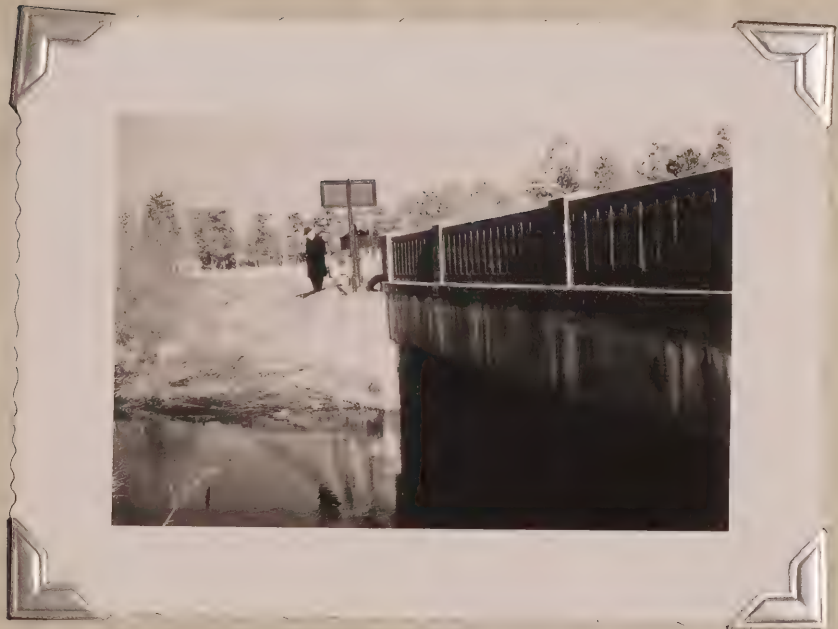
Condition - Coping on abutment on upstream side disintegrated. Exterior girders on both sides cracked accompanied by crystalline deposits. See photo.

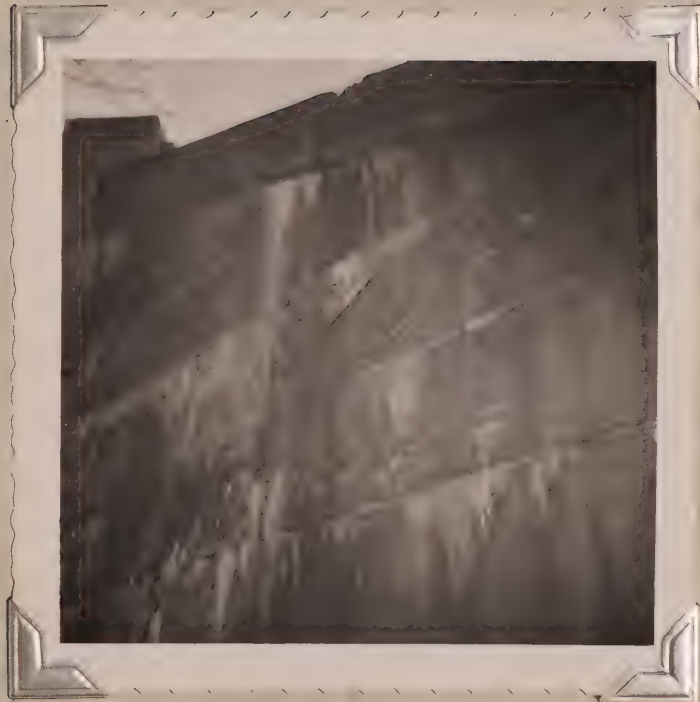
Condition - Vertical crack in one of the piers. Piers
and north abutment have been repaired.
South abutment wing wall deteriorated in
spots. Crystalline deposits on abutment
walls. See photo.

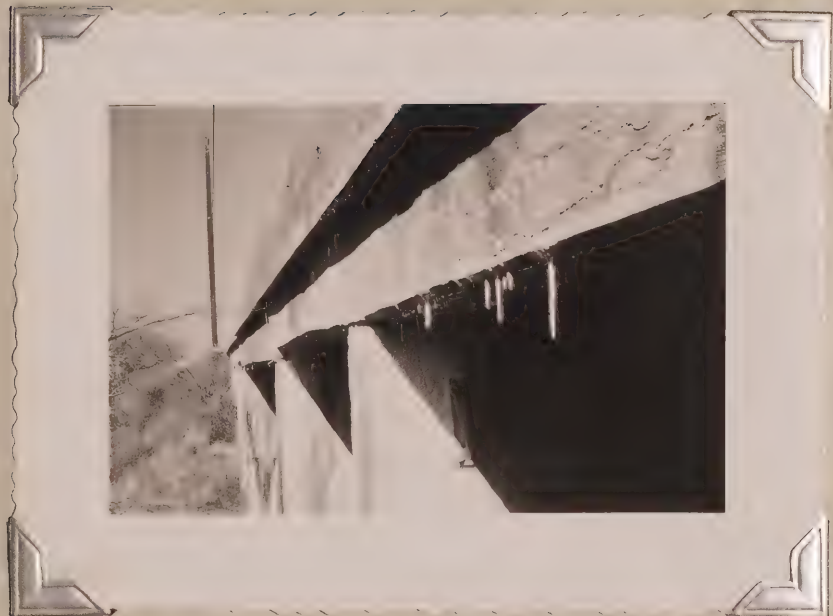
BRIDGE NO. 31

Condition - Considerable cracking on vertical surfaces accompanied with crystalline deposits. Some disintegration at the water table at base of the deck. Crystalline deposits on the underside of deck. See photos.

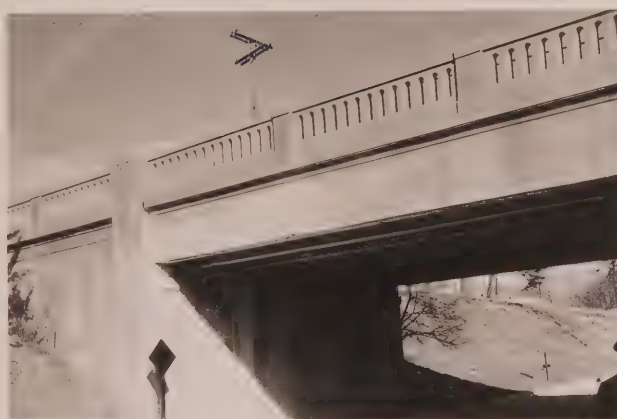
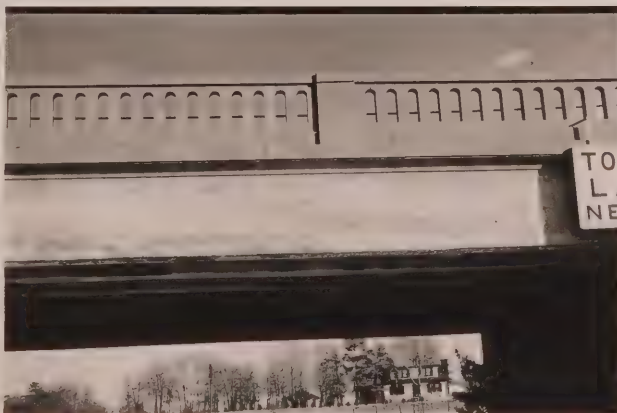
Condition - Minor cracks in exterior girder and some slight spalling of concrete. Crystalline deposits on vertical surfaces of exterior girders. Structure in good condition.

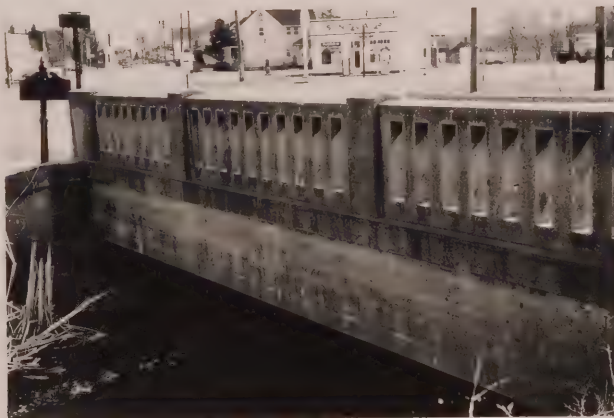
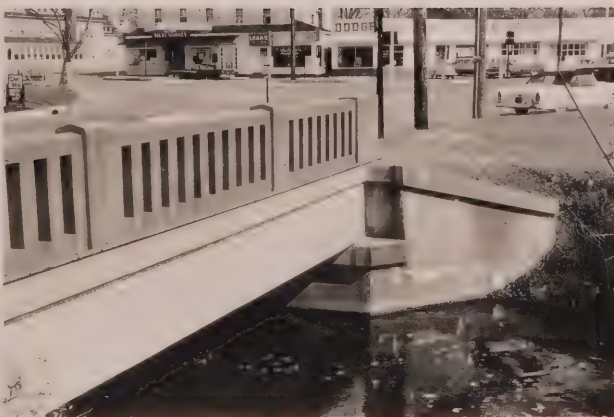
Condition - Horizontal crack in southeast wing wall.
Crystalline deposits on upstream exterior
girder. Bridge is in good condition.
See photos.

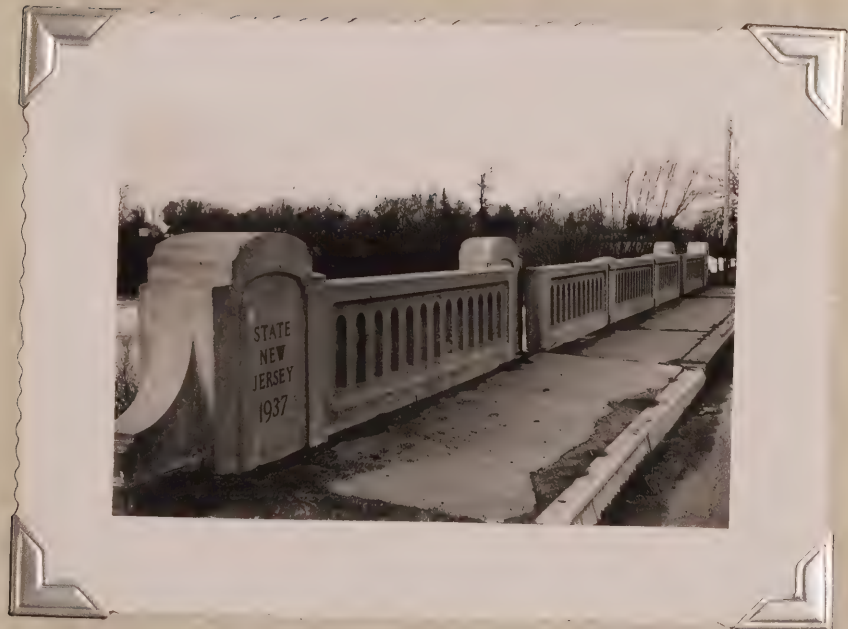
BRIDGE NO. 34

Condition - Vertical cracks in abutments. Vertical cracks in wing walls midway between breast wall and end of wing wall extending thru the balustrade. Movement of abutments as evidenced by opening of the expansion joints in the balustrade on south end. Some minor cracking and spalling in the balustrade. See photos.

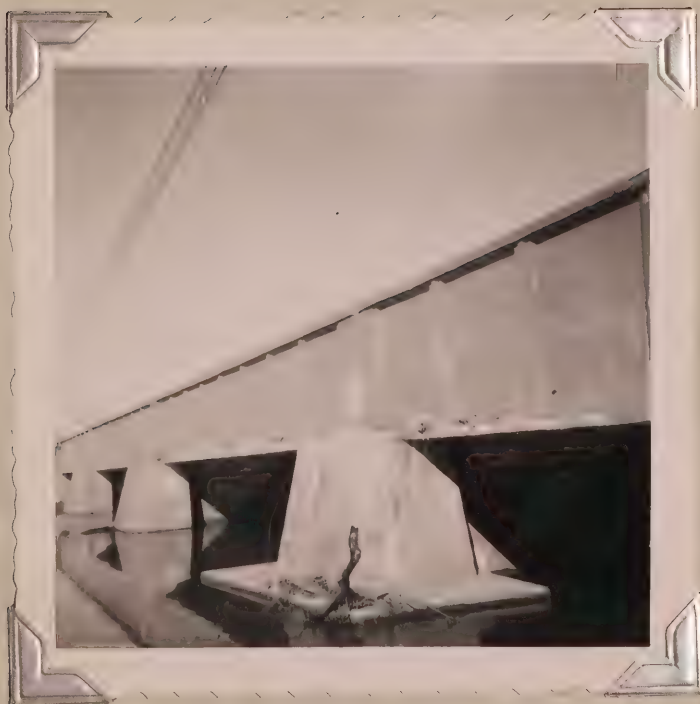
Condition - The bridge has been widened. A different balustrade has been placed on one side which is dated 1940. The downstream face of the bridge in good condition. Concrete at top of the piers and cover over the bottom flange of the girders is disintegrated. See photo.

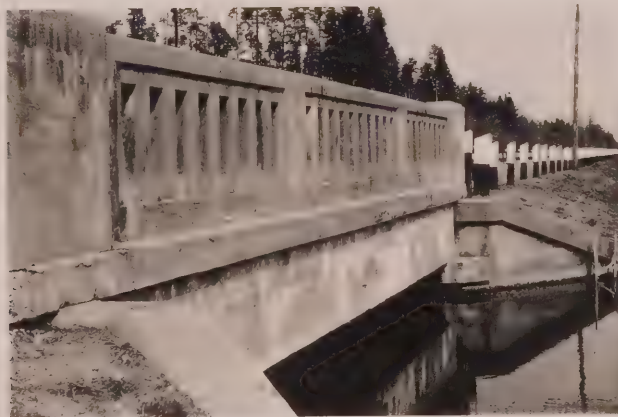
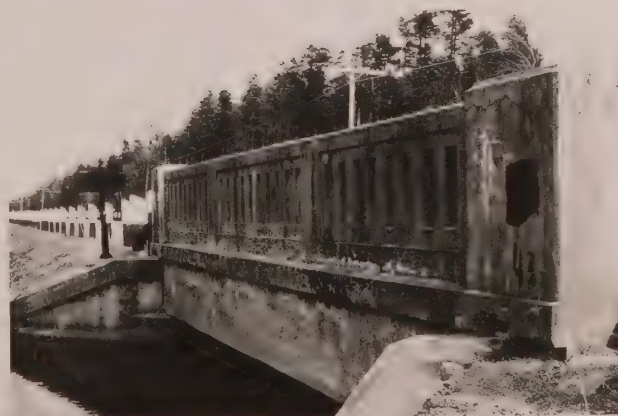
Condition - Horizontal cracks on the side elevation of exterior girders accompanied by crystalline deposits. On the upstream face the concrete has been etched. Where the water table overhangs the wing wall rock pockets occur. End posts of the balustrade are cracked. See photos.

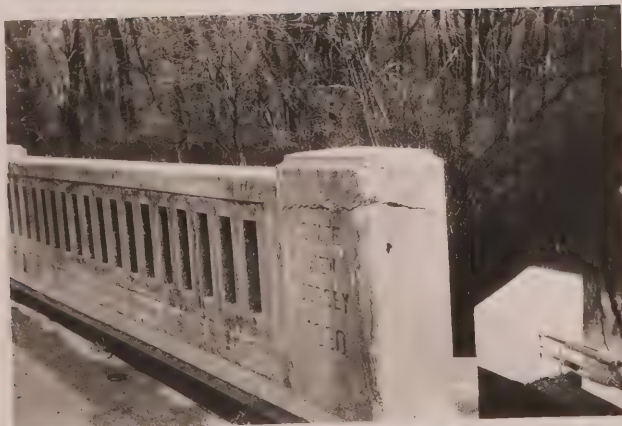
Condition - Wing wall coping at northeast corner disintegrated. All end posts of balustrade badly cracked. Wing wall on upstream face etched. Horizontal cracks at midheight of exterior girders accompanied by crystalline deposits.

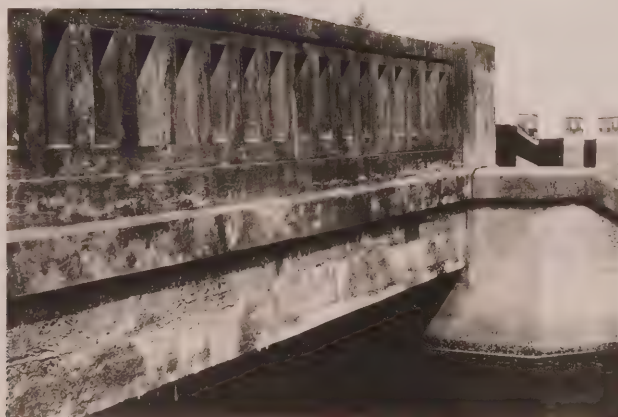
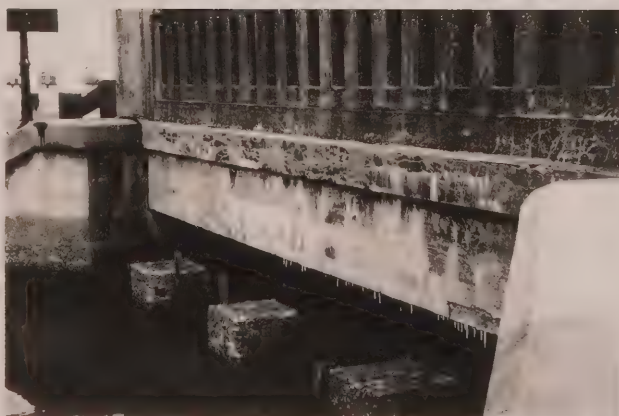
Condition - The structure is in about the same condition as the one at Clarks Brook, Rockwood. The etching in the upstream face is not as pronounced. See photos.

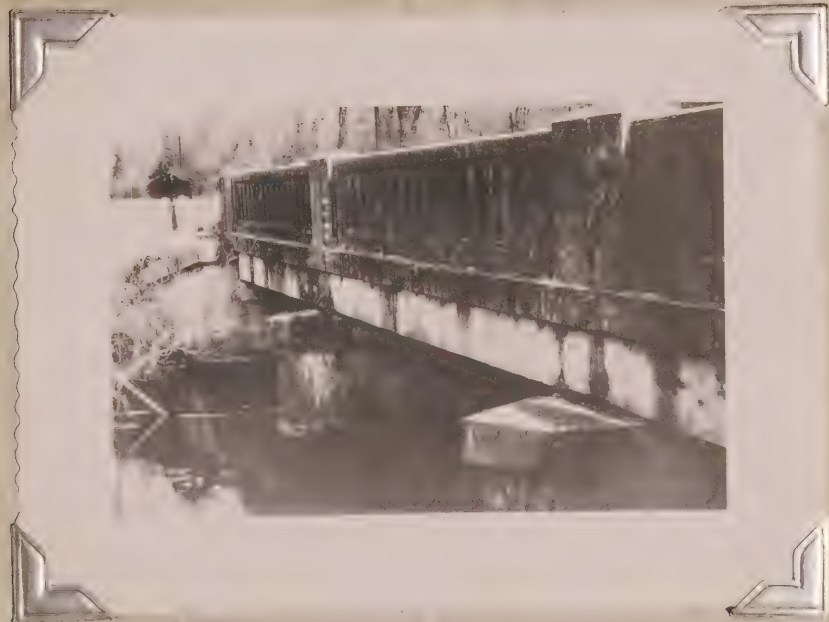
BRIDGE NO. 39

Condition - With the exception of some minor cracking, the structure is in sound condition. Some patch work has been done on the balustrades. See photos.

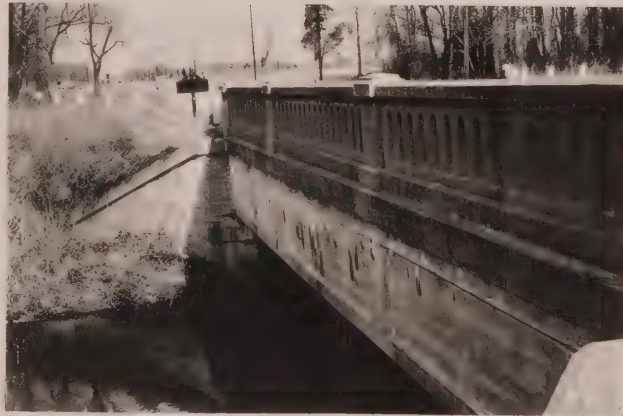
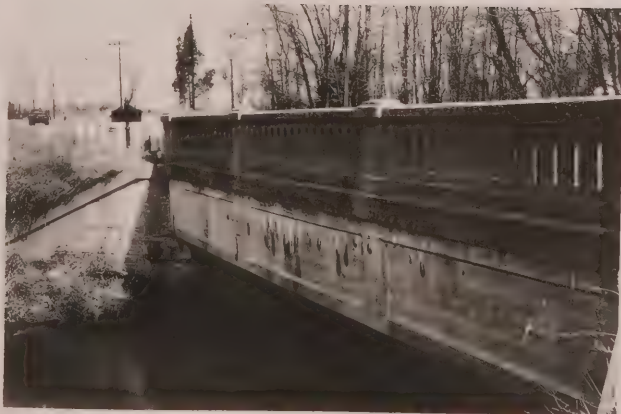
BRIDGE NO. 40

Condition - Etching of concrete at high water line.
Crystalline deposits on all exposed sur-
faces. See photos.

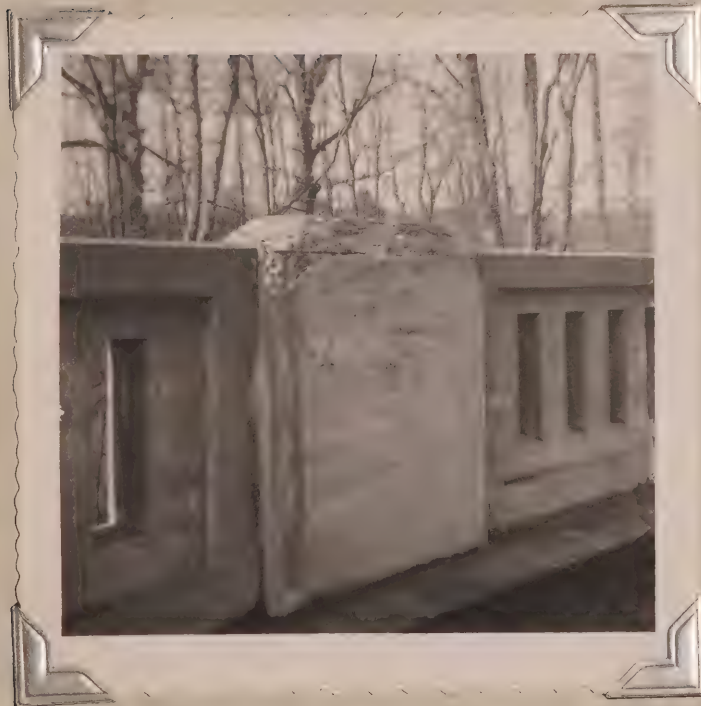
Condition - One vertical crack in pier and in both abutments. Top of post on balustrade on downstream side disintegrated. Exterior girders on downstream side cracked with some spalling. Disintegration of concrete at coping level of one abutment on downstream side. Crystalline deposits on underside of deck and side elevations of bridge. Upstream side of structure in good condition. See photos.

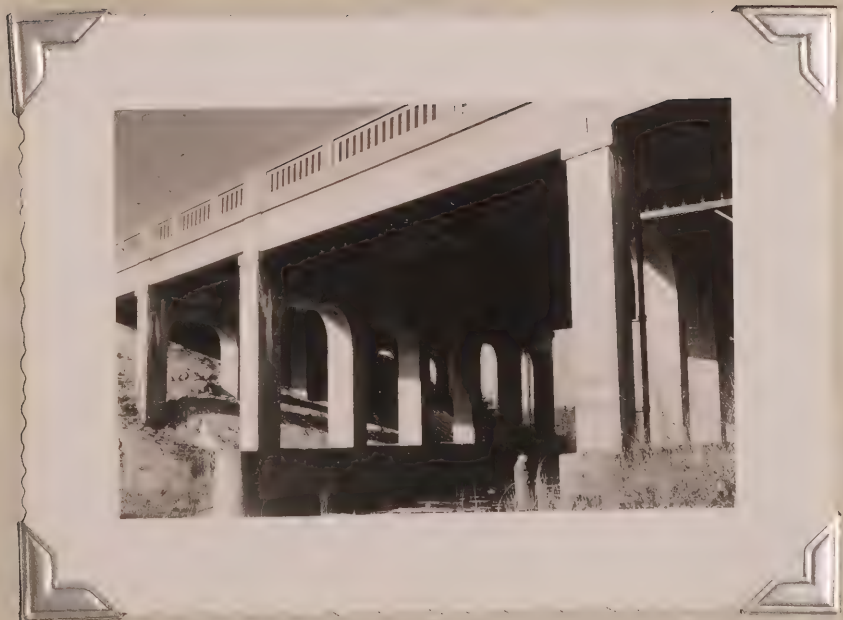
Condition - Balustrade in fairly good condition; cracks at posts and some reinforcing steel exposed. Signs of water seepage thru deck at junction of slab with stem accompanied by crystalline deposits. Some cracks near top of piers. Wing walls cracked at top. See photo.
